The situation

The problem

This particular MOD site near Winchester in the south of England suffered heavy lime scale problems for many years. Different water treatment systems were installed and tested trying to reduce the problems with hard scale as the Plate Heat Exchangers had to be serviced and descaled regularly on a 6 months basis.

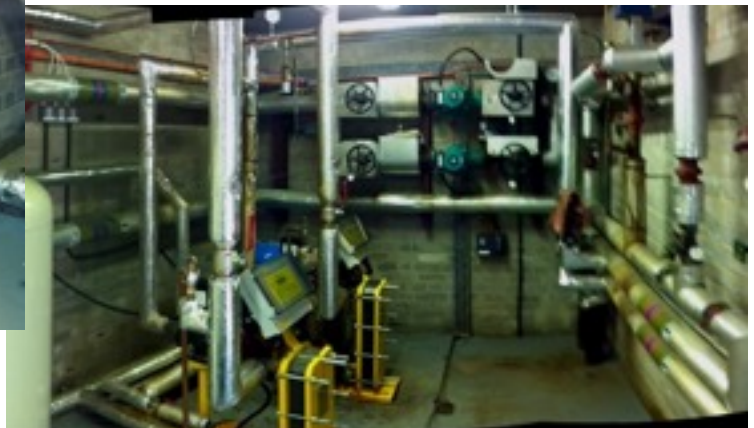
Other water treatment systems did not stop the Plate Heat Exchangers from scaling up

The Plate Heat Exchangers were under a constant costly repair program with a regular 6 monthly descaling program.

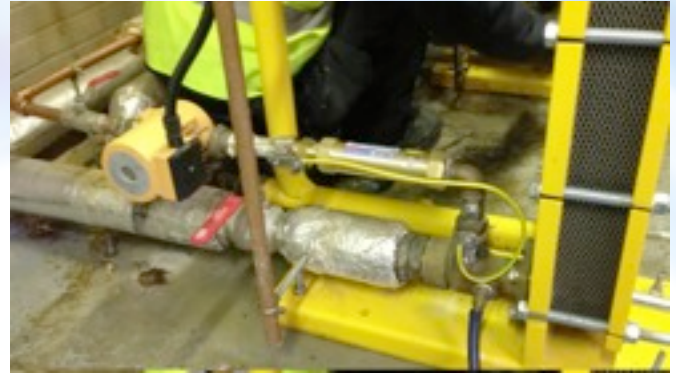
JFK Plumbing & Heating Ltd installed the patented AQUABION® water treatment systems

JFK Plumbing & Heating came up with a special procedure to monitor limescale buildup in plate heat exchangers. The idea was to monitor the flow of water going through the Plate Heat Exchangers would indicate the limescale build up. By monitoring the flow you will clearly prove the amount if any of limescale build up. The combined flow through the heat exchangers will be monitored over a 6 month period. If there is no significant drop in flow over the 6 months the test would prove the successful treatment by Aquabion®.

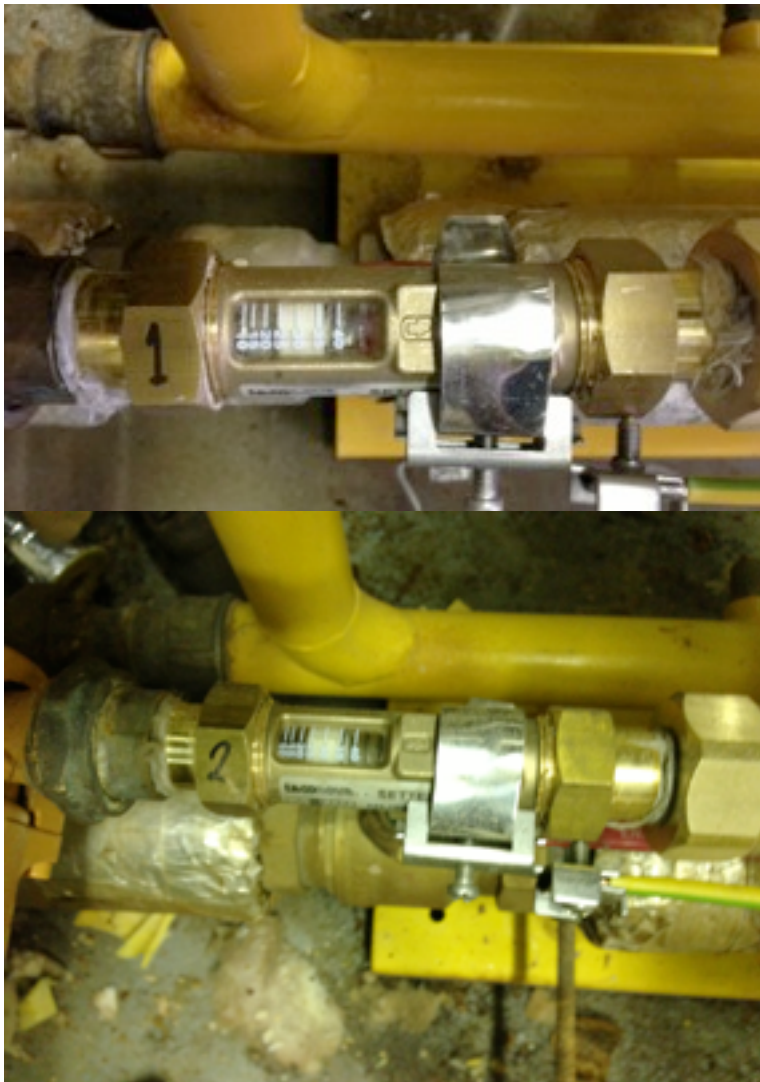
2 flow meters were installed after each pump. The readings show the flow after the scale build up BEFORE and AFTER AQUABION®.

Before the test started at the beginning of January 2013 a total descaling process took place to clean the Heat Exchangers and 2 flow meters were installed by JFK Plumbing & Heating Ltd plus the AQUABION® systems. 1 system AQUABION® H40 was installed on the cold water mains as well as 2 systems AQUABION® S20 on the secondary return, after the pumps.

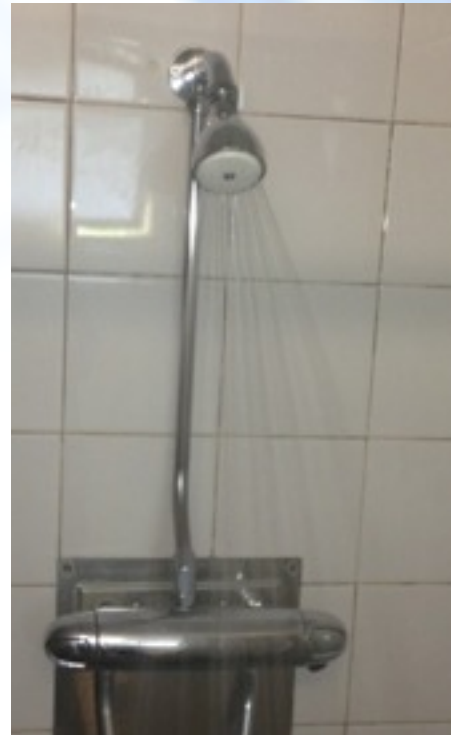
After 6 months: The showers are clean and were in no need to be serviced and descaled.

Shower heads also caused a severe problem and were in constant need for non aggressive water to function properly as they needed constant descaling every 3 months.

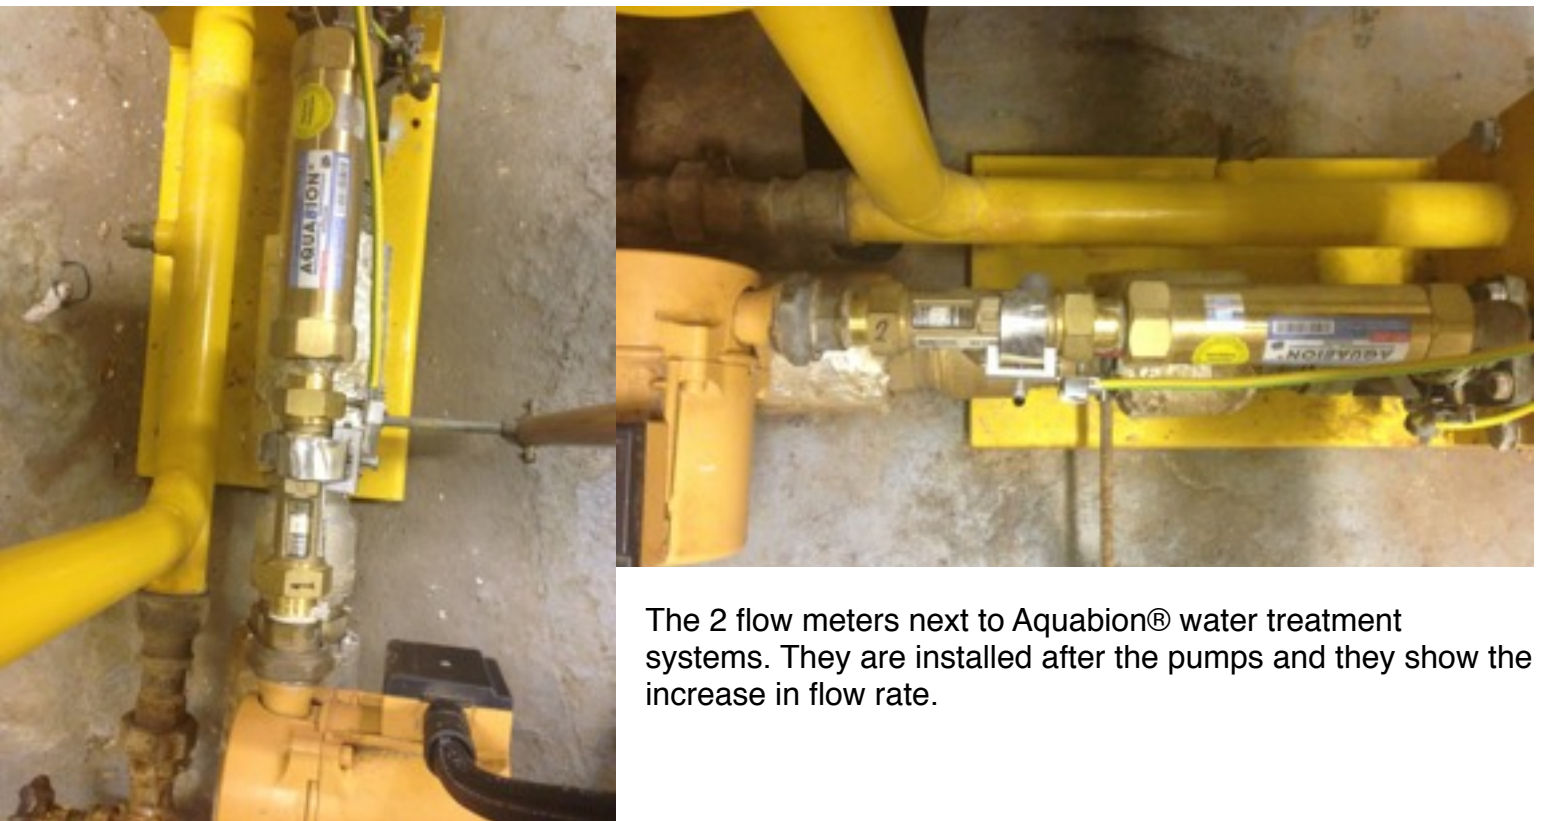
The 2 flow meters next to Aquabion® water treatment systems. They are installed after the pumps and they show the increase in flow rate.

Pump 1 = 29L/ pm an 4L/ pm increase in flow rate.

Pump 2 = 22L/ pm with no loss in flow rate.

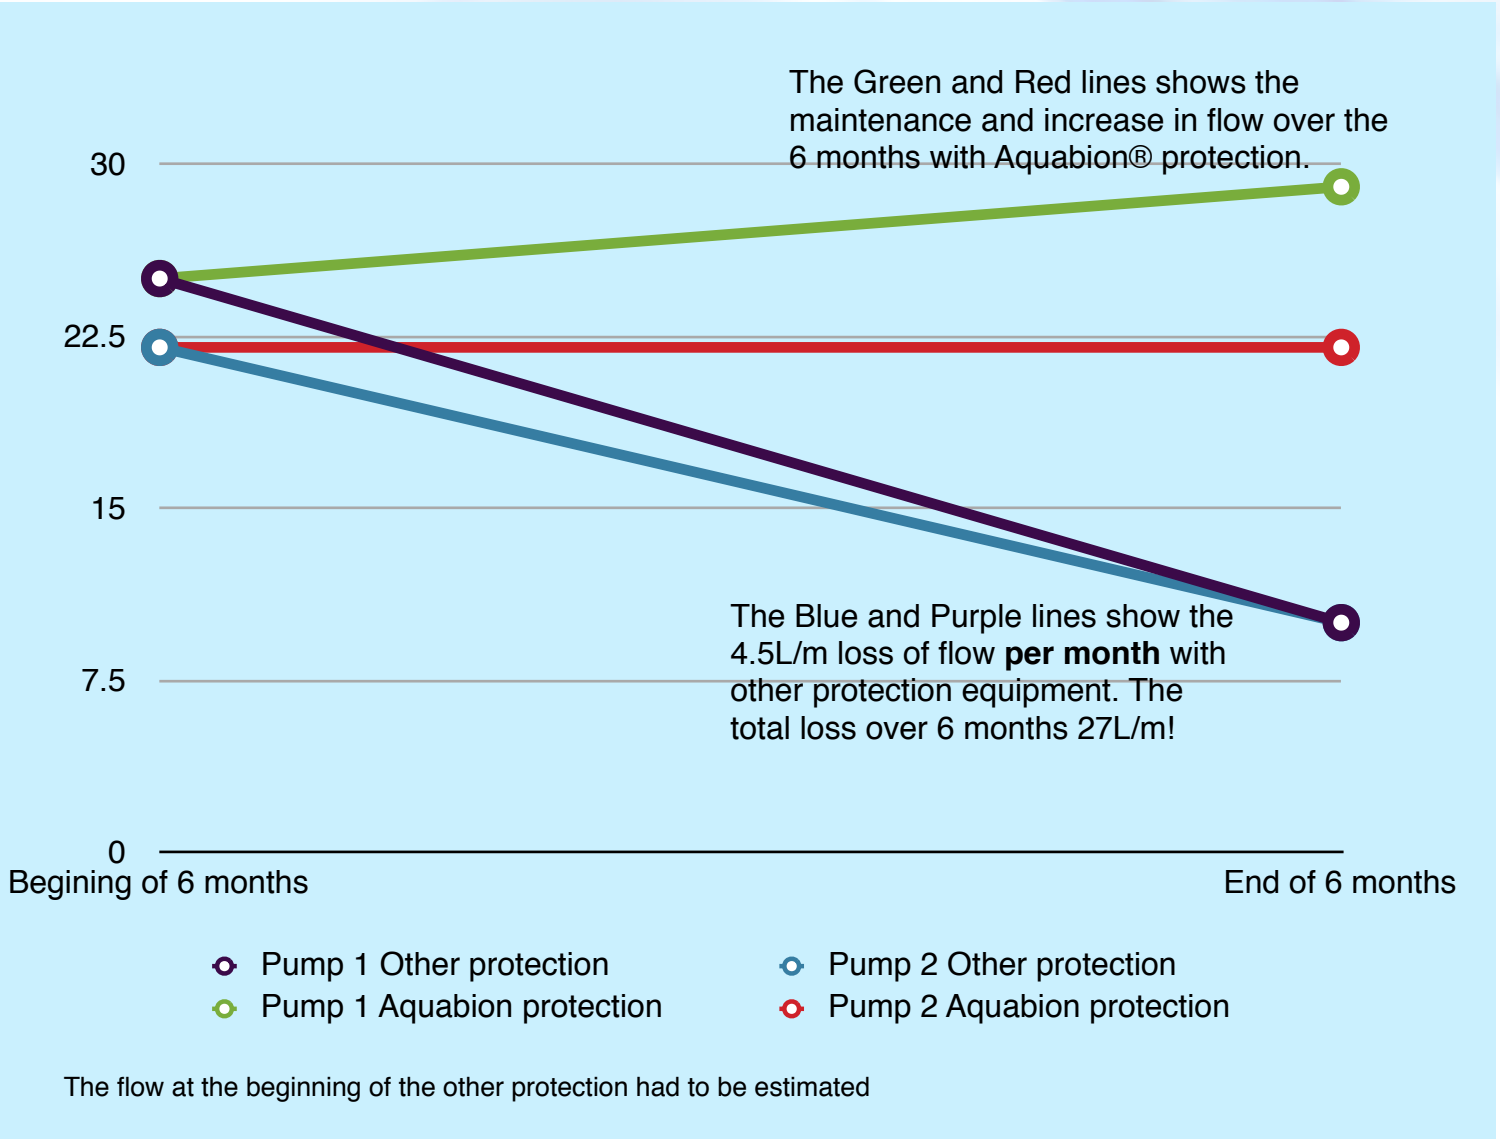
This Graph shows the water flow through the Plate Heat Exchangers over a 6 month period between 7/1/2013 and 30/6/2013

At the end of the 6 month test in June 2013 - 6 months after the AQUABION® water treatment systems were installed - there has been an increase of 4L/ pm!

Individual readings are:
